**Flood Control Project Maintenance
Levee Inspections**
LMA District Cover Sheet
Spring 2019 Levee Inspection Results

Reclamation District No. 0341 Sherman Island

Spring 2019 Levee Inspection Results

Waterway			Bank	Unit Miles
Unit No. 01 Threemile Slough			Right	3.36
	Spring (March - May)	Summer (June - August)	(September - November) Fall	Winter (December - February)
Unit Maintenance Rating (Fall Only)				
Date of Inspection	3/28/2019 - 3/28/2019			
DWR Inspector	David Julian			
Accompanied By	Wade Wylie DWR

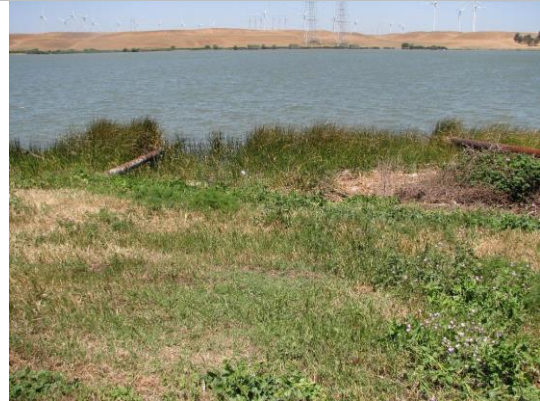
Photo 1 of 3 : UCIP_SP_2019_22293_38041.jpg

Comment Code						
Inspector Comment						
FS_ID:22293 DS_ID:24128 EP_NO: 1915 Repair Type: Non-Urgent Crossing Status: Found UCIP Comments: Will need to contact owner. Need to obtain maintenance records and clarify modifications made at to crossing (size). Also important to note that DWR DOE was out in the field during our pipe inspection they were conducting pipe evaluation for pipe replacement. Need to contact DWR DOE to determine location of pipe replacement. FIELD_STRUCT_DESC: 18-inch (not 12-inch as noted in historical records) steel irrigation pipe through the levee, 3.0 feet below the crown. 30-inch concrete standpipe riser on landside (LS). (Permit No. 1352-1948) Siphon breaker on landward side installed under Permit No. 1915 (1954). Pipe removed and replaced by 12-inch steel pipe under Permit No. 10799 (1977). (12-inch siphon pipe authorized under Permit No. 1352, 1948 - Celli Brothers; 12-inch pipe and 20-inch pipe approximately 4,900 feet and 9,400 feet downstream (D/S), respectively, from Emmaton authorized under Permit No. 1915, 1954 - Celli Brothers; 12-inch pipe authorized to replace existing 12-inch pipe under Permit No. 10799, 1977 - Gene Celli) [Additional Reference(s): DWR Levee Log, 1992. LMA encroachment station (STA) reference based on Map of Evacuation Route, Reclamation District 341 Sherman Island by Wagner Bonsignore Consulting Civil Engineers, A Corporation dated July 2012, STA 799+00] FS Date: 5/6/2009

Overview of waterward side-18-inch pipe located on right side and 12-inch pipe located on left side.

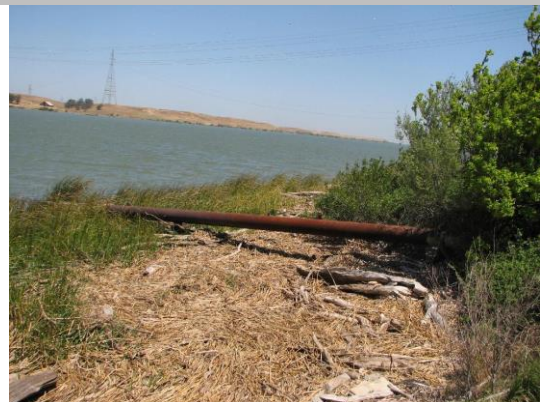
Photo 2 of 3 : UCIP_SP_2019_22293_38040.jpg

View of crossing located on waterward side.

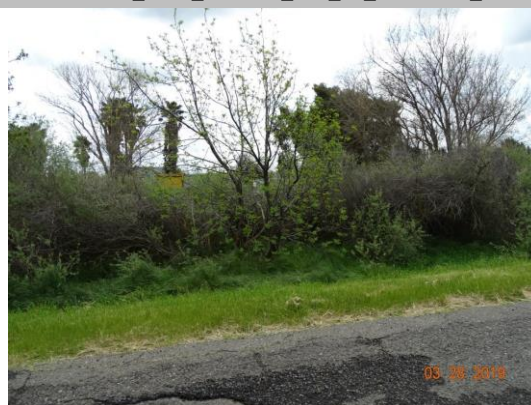
Photo 1 of 1 : SP_2019_RD0341_168_51_20190329_00089.jpg

LM Start	7.78	Rating **	U	Issue No.	51
LM End	7.78	Issue Type +	En	Location *	LS
Category	Earthen Levee			GPS Latitude/Longitude	
				Start	End
Item	Vegetation			38.075008 °	38.075008 °
				-121.755815 °	-121.755815 °
DWR ID	DWR_RD0341_02_s_2019_51				
Comment Code					
V6 : Landscaping					
Inspector Comment

View looking downslope at landscaping on the landside slope (Spring 2019).

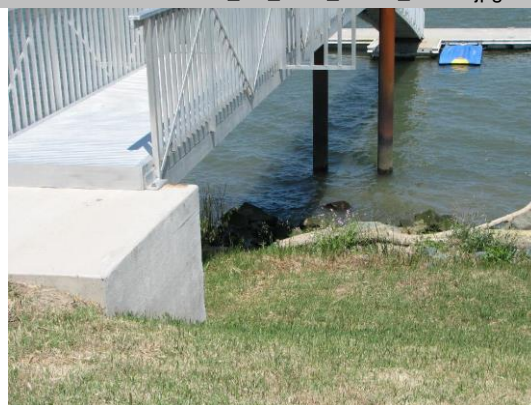
Photo 1 of 3 : UCIP_SP_2019_22303_38062.jpg

Comment Code					
Inspector Comment					
FS_ID:22303 DS_ID:24246 EP_NO: N/A Repair Type: Non-Urgent Crossing Status: Found UCIP Comments: Need to determine the status of conduit--has construction been completed? FIELD_STRUCT_DESC: Four 2.5-inch conduits sleeved through 12-inch steel pipe through the levee at an unknown depth below the levee crown. Boat launching dock and ramp are located on the waterside (WS). [Additional Reference(s): LMA encroachment station (STA) reference based on Map of Evacuation Route, Reclamation District 341 Sherman Island by Wagner Bonsignore Consulting Civil Engineers, A Corporation dated July 2012, STA 778+00] FS Date: 5/6/2009

View of waterward side. Conduit goes through concrete structure connecting walkway.

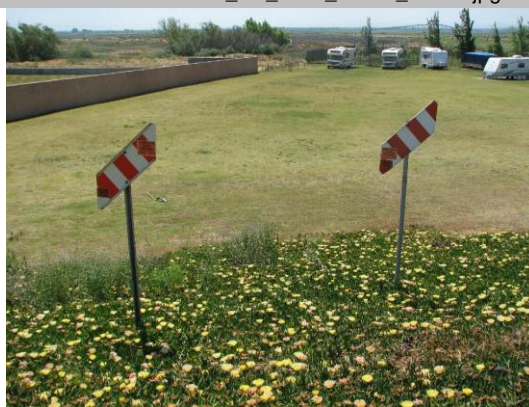
Photo 2 of 3 : UCIP_SP_2019_22306_38066.jpg

Gas line markers visible on landward side.

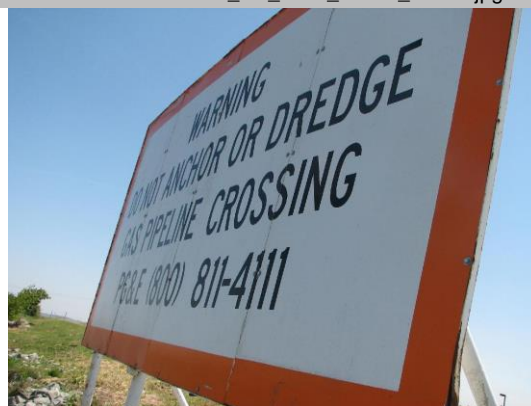
Photo 3 of 3 : UCIP_SP_2019_22306_38065.jpg

Comment Code						
Inspector Comment						
FS_ID:22306 DS_ID:24130 EP_NO: 3494 Repair Type: Non-Urgent Crossing Status: Indicator Found UCIP Comments: Need to contact owner to determine status of crossing. Need date of last inspection and confirmation that crossing is still in operable condition. FIELD_STRUCT_DESC: 1 of 2: 26-inch concrete encased steel gas line through the levee, 5.1 feet below the crown. Concrete cutoff wall around pipe at center of levee. Location sign on waterward shoulder. Rock revetment on waterward slope. Contact number listed on marker out in the field 1-800-811-4111. (two 26-inch lines authorized under Permit No. 3494, 1961 - Pacific Gas and Electric Company [PG&E]) [Additional Reference(s): DWR Levee Log, 1992. [LMA encroachment station (STA) reference based on Map of Evacuation Route, Reclamation District 341 Sherman Island by Wagner Bonsignore Consulting Civil Engineers, A Corporation dated July 2012, STA 756+00] FS Date: 5/6/2009

Gas line crossing sign located on waterward side.

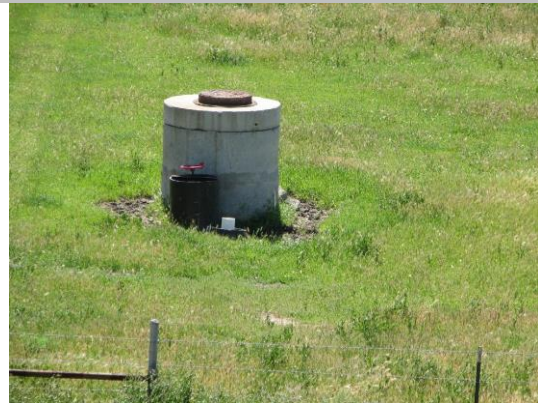
Photo 1 of 3 : UCIP_SP_2019_22309_38075.jpg

Comment Code						
Inspector Comment						
FS_ID:22309 DS_ID:24247 EP_NO: N/A Repair Type: Non-Urgent Crossing Status: Found UCIP Comments: 7/6/2016 Meet with Joel McElroy, District Representative, at site. DWR Bay Delta Division owns pipe. Pipe is active. Need to contact owner to determine permit authorizing pipe crossing. (DWR UCIP - O. Magana) 05/06/2009 New record found in the field. Unable to find any information for crossing during DWR desk study. Will need to find the owner and obtain records for crossing. Need to coordinate with CVFPB. (DWR UCIP - O. Magana) FIELD_STRUCT_DESC: 10-inch steel irrigation pipe through the levee, at a shallow depth below the crown. Air vent on the waterside (WS). Distribution box with slide gate and observation well on the landside (LS). Pumping station on the LS. Rip rap located on WS. [Additional Reference(s): LMA encroachment station (STA) reference based on Map of Evacuation Route, Reclamation District 341 Sherman Island by Wagner Bonsignore Consulting Civil Engineers, A Corporation dated July 2012, STA 751+00] FS Date: 5/6/2009

Concrete stand pipe and gate valve located on landward side.

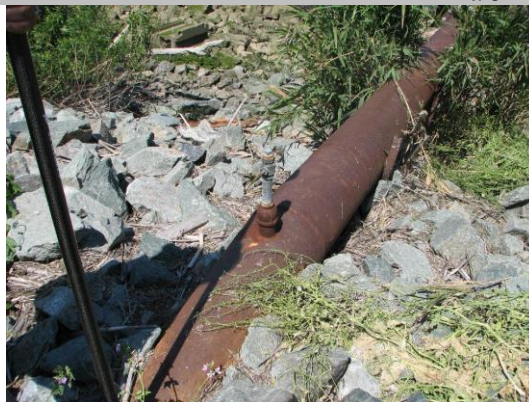
Photo 3 of 3 : UCIP_SP_2019_22309_38077.jpg

Siphon breaker visible on waterward side. Levee toe is armored with rock slope protection.

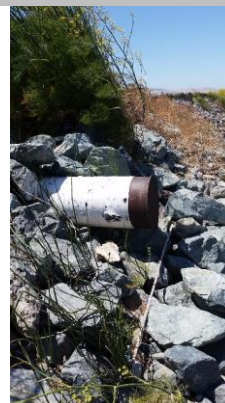
Photo 2 of 3 : UCIP_SP_2019_50082_75942.jpg

New pipe(non-functional) metal plate installed on the WS.

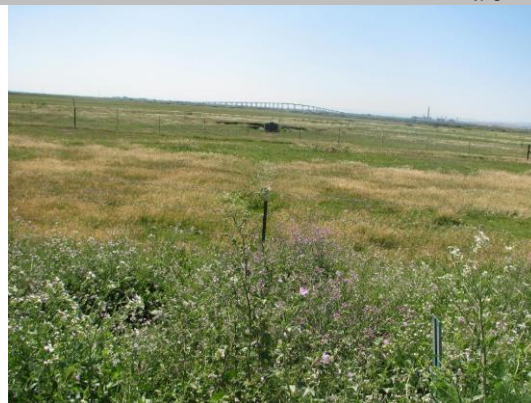
Photo 3 of 3 : UCIP_SP_2019_22324_38094.jpg

Comment Code						
Inspector Comment						
FS_ID:22324 DS_ID:24133 EP_NO: 11114 Repair Type: Non-Urgent Crossing Status: Found UCIP Comments: 7/6/2016 Meet with Joel McElroy, District Representative, at site. DWR Bay Delta Division owns pipe. Need to contact owner to determine status of pipe crossing. (DWR UCIP - O. Magana) 05/06/2009 Dense vegetation limits the inspector's visibility to identify signs of pipe failure (leaks) along the slope. Recommend removing vegetation along pipe alignment to conduct proper inspection of structure and appurtenances. (DWR UCIP - O. Magana) FIELD_STRUCT_DESC: 14-inch steel pipe of unknown purpose through the levee, 4.0 feet below the levee crown. Concrete standpipe with slide gate located on the landside (LS). Rock revetment on the waterside (WS) slope. (14-inch pipe retained under Automatic Board Order (ABO) issued as Permit No. 11114, 1975 - E. J. Trigueiro) [Additional Reference(s): DWR Levee Log, 1992. LMA encroachment station (STA) reference based on Map of Evacuation Route, Reclamation District 341 Sherman Island by Wagner Bonsignore Consulting Civil Engineers, A Corporation dated July 2012, STA 720+00] FS Date: 5/6/2009

Overview of landward side.
